2001 Annual Site Inspection and Monitoring Report for Uranium Mill Tailings Radiation Control Act Title I Disposal Sites

January 2002

2001 Annual Compliance Report Canonsburg, Pennsylvania, Disposal Site

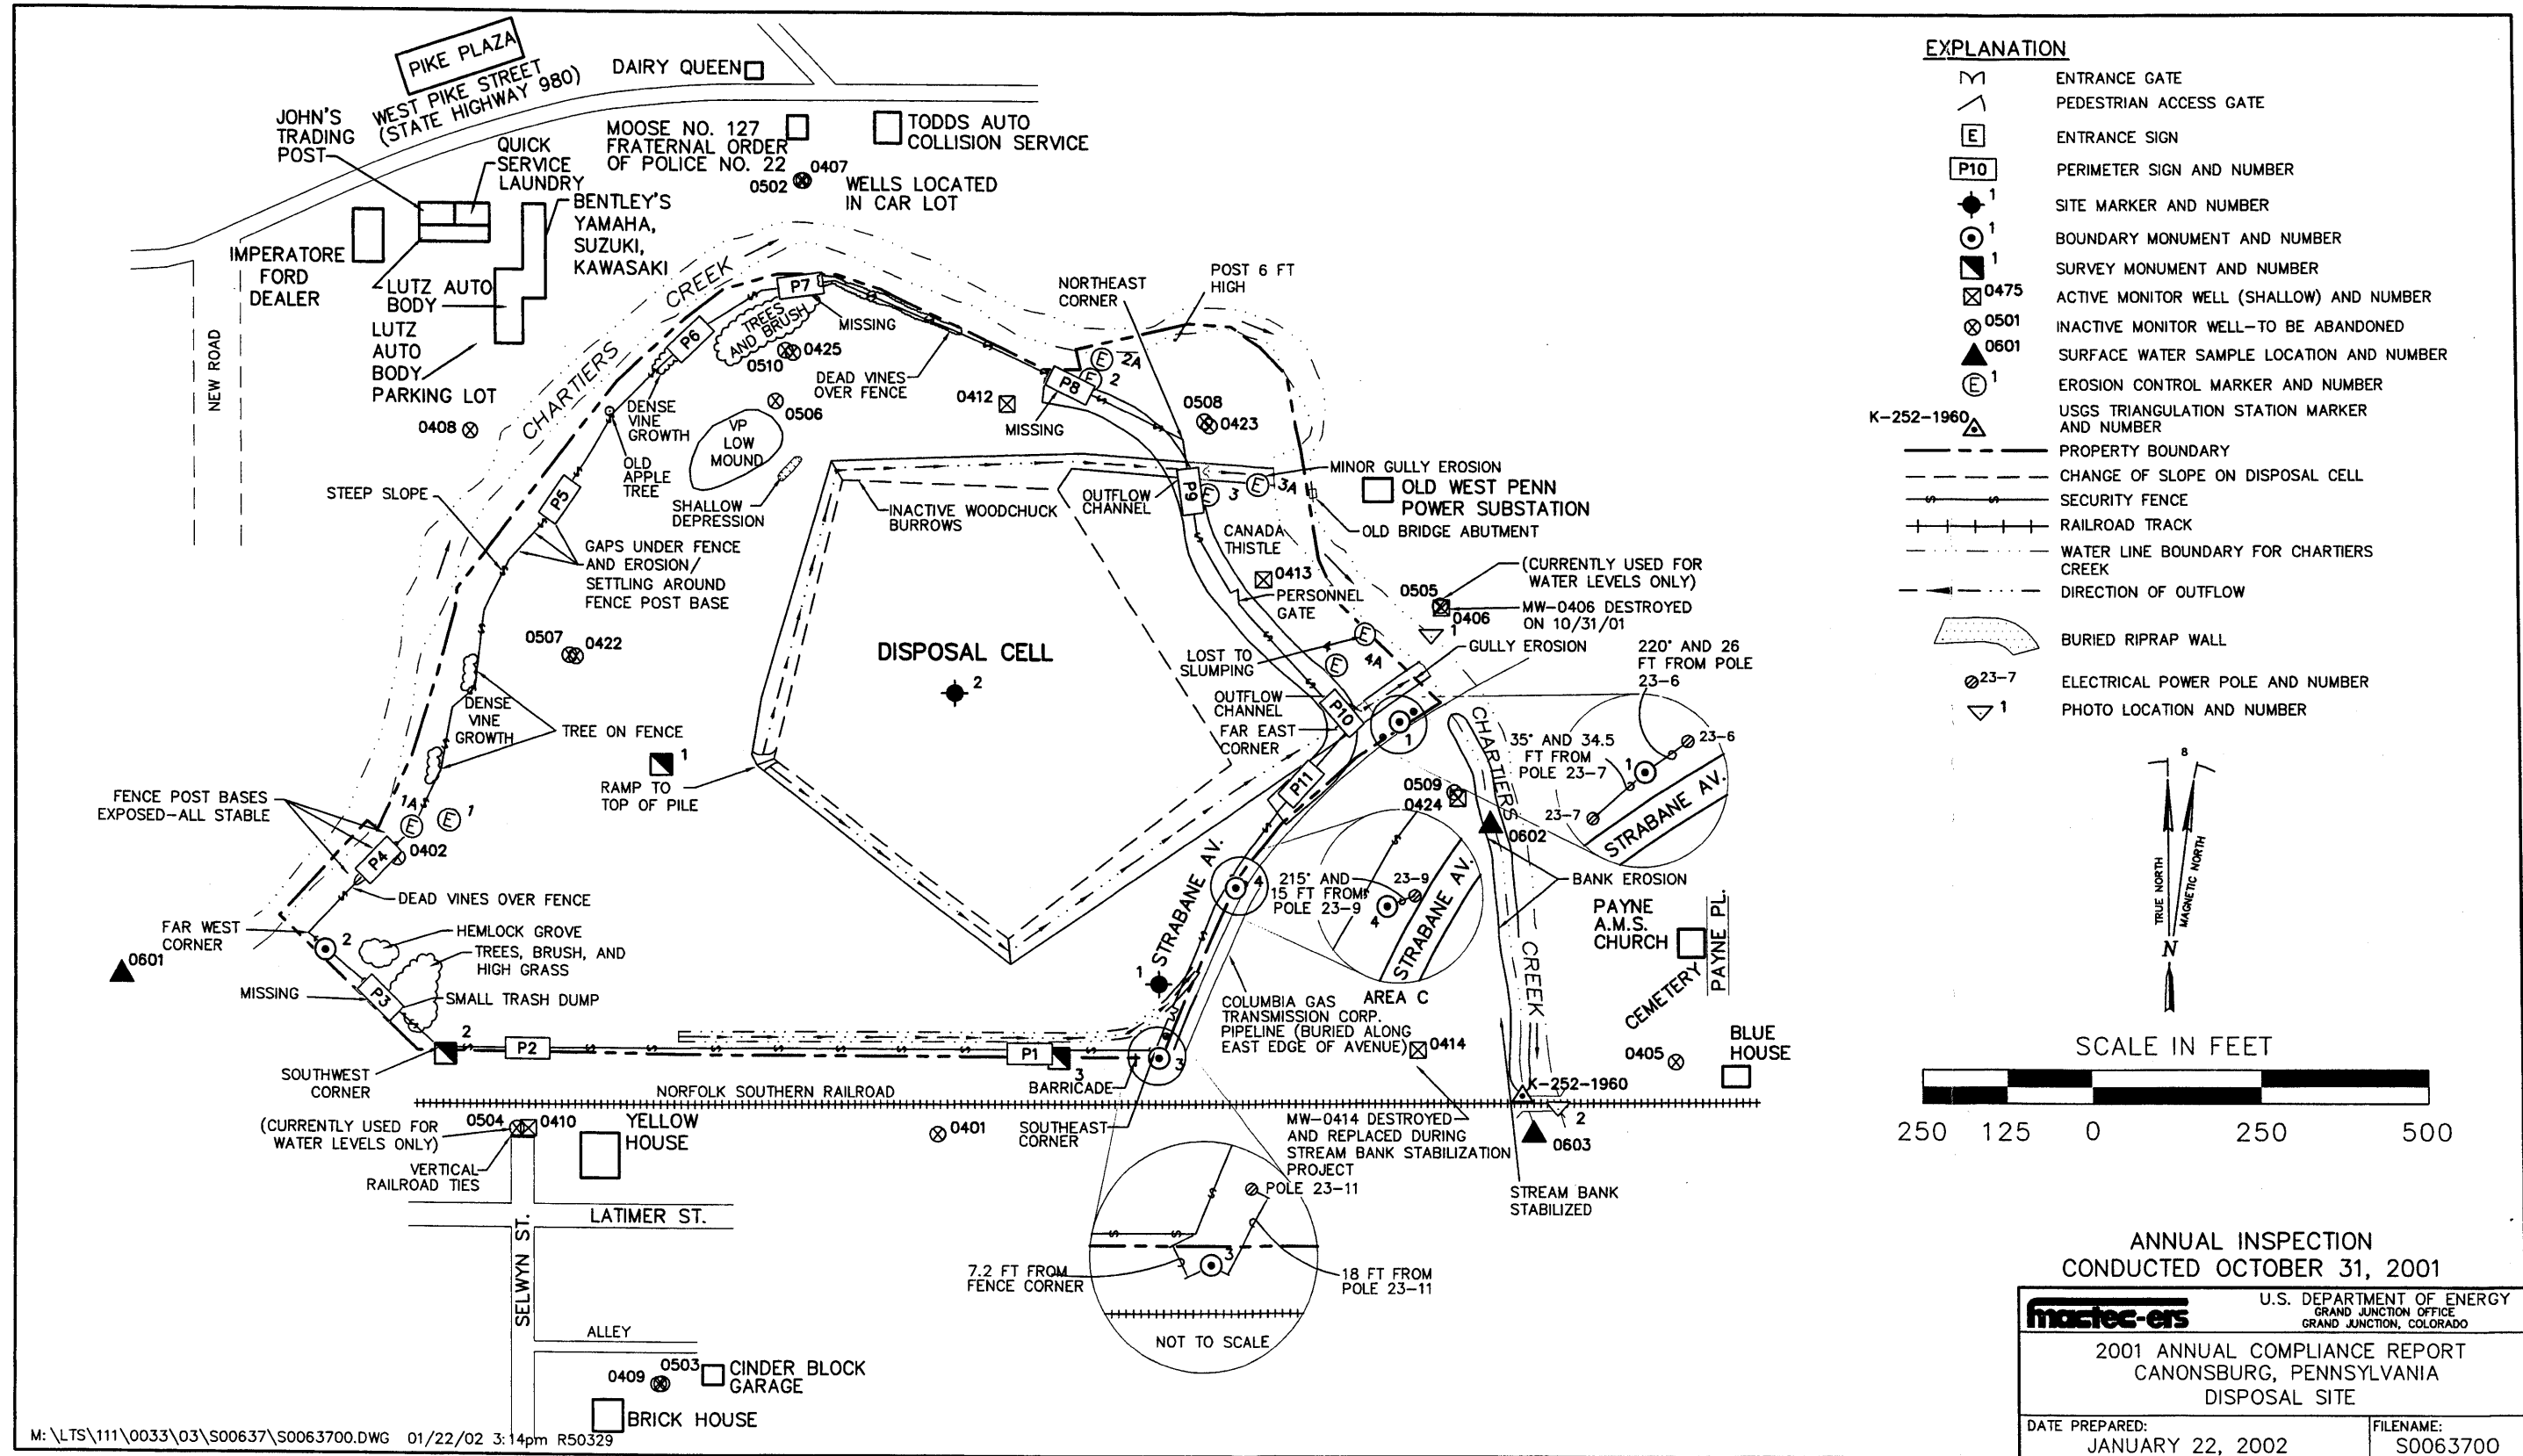
Figure 3-1. 2001 Compliance Drawing for the Canonsburg, Pennsylvania, Disposal Site

The site, located between the communities of Canonsburg and Houston, Pennsylvania, was inspected on October 31, 2001. Features and photo locations mentioned in this report are shown on Figure 3-1. Numbers in the left margin of this report refer to items summarized in the Executive Summary table.
